## IN-SITU ANNEALING SAVES CRUISE SHIP CRANKSHAFT IN-SITU MACHINING AND ANNEALING SALVAGE SULZER 12 ZAV 40S CRANKSHAFT

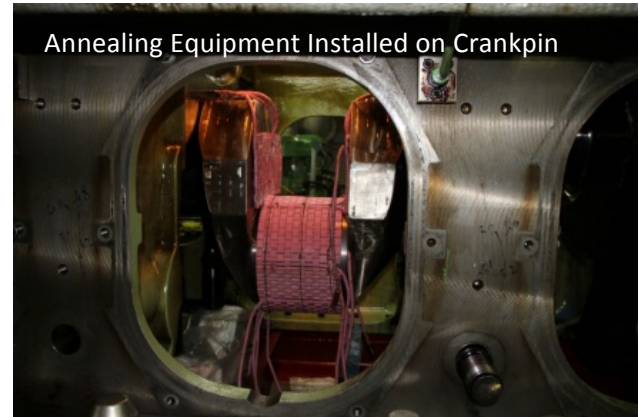
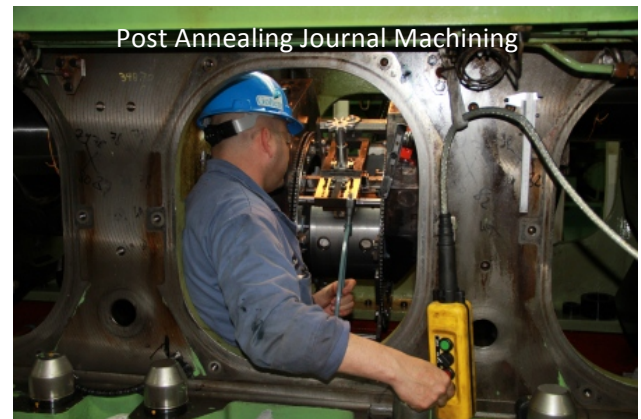
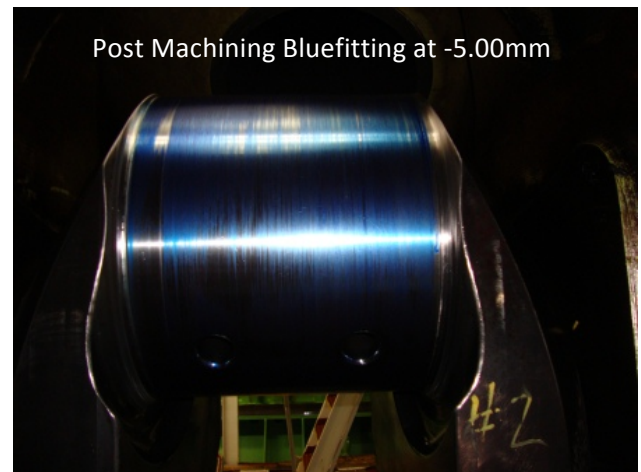
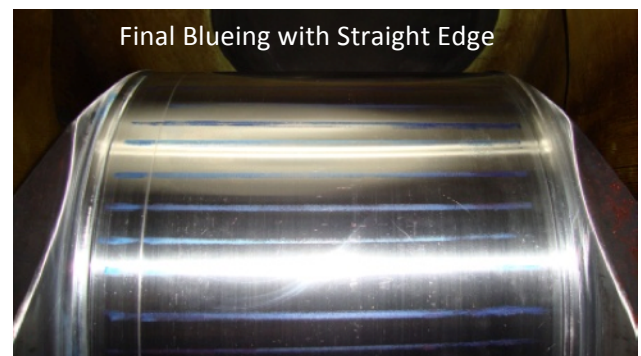
Inspection revealed that the crankpin journal was damaged all around the journal surface with scoring and bearing material. Additionally, technicians found a large area in the bottom side of the journal with hardness values above 600 HB. Run out measurements showed a maximum deficiency of 0.08mm.

After assessment, the journal was machined down -2.00mm (diameter 348.00mm) until the damaged journal surface was clean of foreign material and cracks. However, the high hardness values remained.

The customer decided to cut another -2.00mm to see if the hard area would get smaller and the hardness values would get lower. At diameter 346.00mm the hardness values and area were still out of the engine maker's specifications.

Goltens proposed performing its crankshaft annealing procedure to save the shaft within the maximum undersize diameter and hardness values given by the engine maker.

Goltens' full spectrum In-Situ machining capabilities and its well tested annealing process reduced the hardness in the crankshaft to acceptable levels and saved the ship's crankshaft and avoided a costly crankshaft replacement and unnecessary downtime.
