IN-SITU ANNEALING SAVES CRANKSHAFT CONDEMNED BY THE ENGINE MAKER MAN B&W 6L48/60 MAIN ENGINE CASUALTY

PROJECT FACTS: MAN 6L48/60 ANNEALING

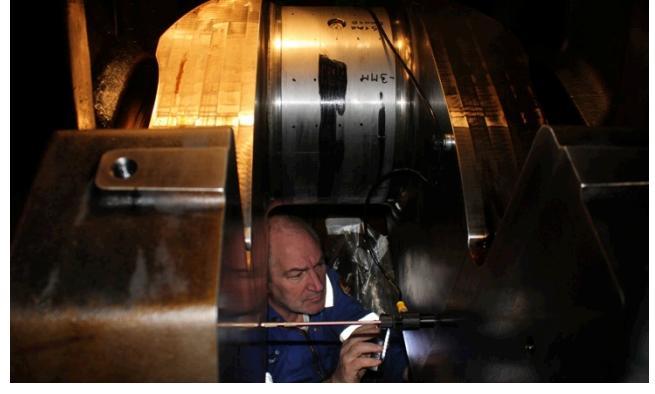
Checking deflection at -3mm before annealing

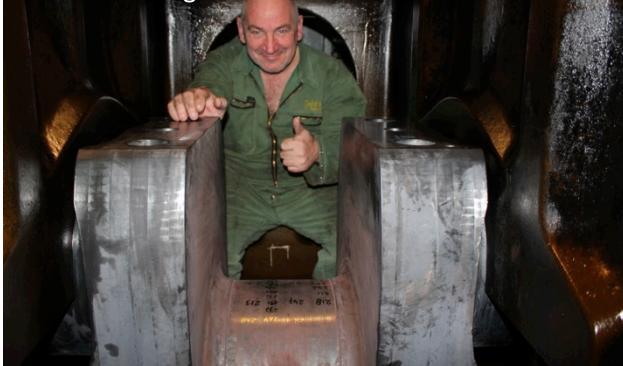
Post annealing hardness reduced to <300 hB

Once preparations were taken care of, Goltens completed the annealing of the crankpin and subsequent testing showed that the hardness had been successfully reduced to below 300 Brinell. The shaft was then carefully peened and the straightness of the shaft was restored. Goltens then set up its single-point cutting tools, finished machined the journal to -5mm and then machine polished it to its finished surface.
