## IN-SITU SHAFT MACHINING RESTORES FULL CAPACITY OF DUTCH POWERSTATION IN ONLY FOUR DAYS

### MACHINING AND HONING OF STEAM TURBINE GENERATOR ROTOR SHAFT

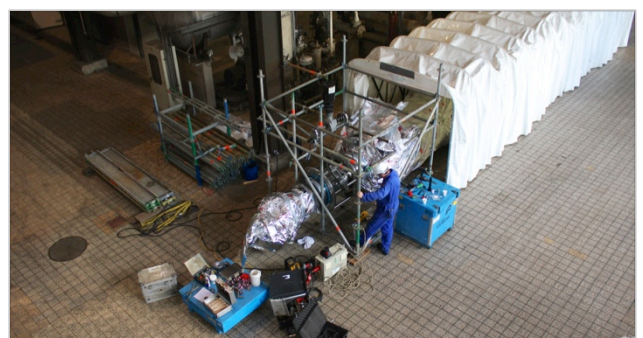
During operations at one of the power stations of a major European electrical supplier, a lack of lubrication caused damage to one of the rotor shafts. The power station operators asked Goltens' experienced In-situ engineers to evaluate the situation and determine the correct repair procedures. After inspection of the shaft-end by Goltens' engineers, it was proposed to machine the shaft in-place to minimize the cost of the repair and the downtime of the generator.

- Inspection of the damaged shaft
- Installation of machining tools and equipment
- Machining of rotor shaft-end to undersize -1.5 mm (528.5 mm)
- Honing of rotor shaft-end to obtain final roughness of 0.2 Ra
- Inspection of end result and checking of straightness and surface roughness

Working around the clock with multiple teams, the shaft-end was machined and honed to a final diameter of 528.50 mm with a surface roughness of 0.2 Ra. The plant was then ready to rebuild the generator to restart the generation process.
