IN-SITU X-Y MILLING ON BADLY DAMAGED MAIN ENGINE GUIDE RAILS MITSUBISHI 6UEC52LA CASUALTY RESTORED IN ONLY 10 DAYS

PROJECT FACTS:	HAI FENG 618
Vessel type:	Refrigerated Cargo Ship
Tonnage:	7,934 DWT
Main Engine:	Mitsubishi 6UEC52LA
Power:	7,061 KW

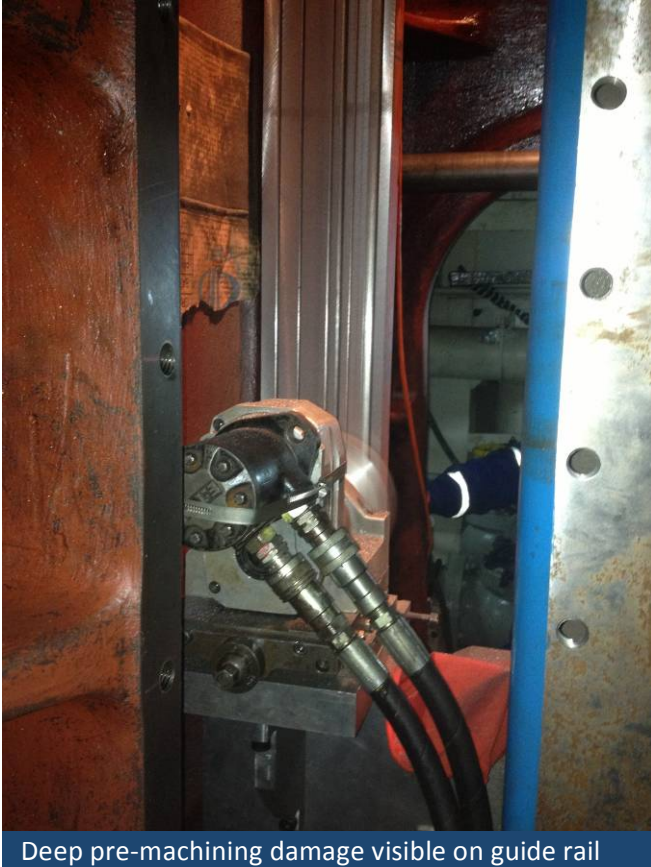
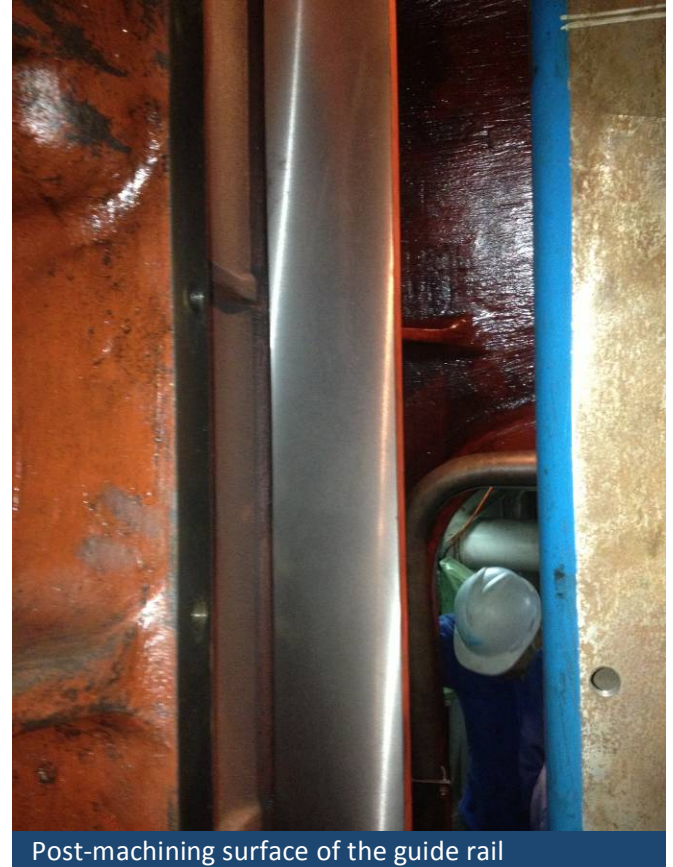
At the ship manager's request, Goltens immediately dispatched their In-Situ Machining Supervisor together with their Technical Manager to check the main engine guide shoe condition. Goltens' inspection revealed severe and deep scoring all along the length of the guide shoe support rails on 3 cylinders as well as serious damage to the guide bearings.

Goltens' In-Situ specialists modified their in-situ X-Y milling machinery in their workshop to fit within the engine crankcase. After modification at Goltens workshop, the tools were immediately transported to vessel engine room where Goltens' diesel specialists had dismantled the damaged cylinders.

Goltens' Diesel, Rebabbiting and In-Situ Machining service teams completed the entire job within 10 days, inclusive of workshop preparation and mobilization work. This was a full week earlier than committed to the owner significantly reducing the downtime and expense for the owner.
