# ON-SITE MACHINING OF DAMAGED GAS TURBINE SHAFT IN SAUDI ARABIA

## FIAT TG 20 B-7/8 GAS TURBINE FOR SAUDI ELECTRIC COMPANY

NAJRAN POWER PLANT

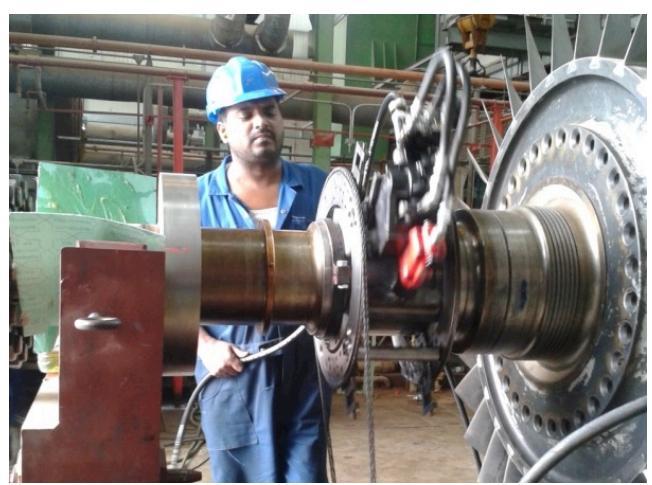
MPI Crack tests being performed on Journal

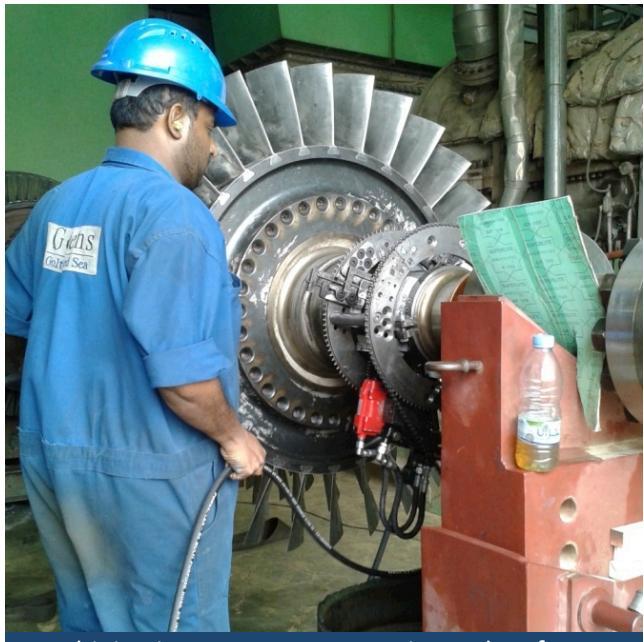
- MPI tests showed no cracks on compressor or exhaust side journals
- Hardness checks found hardness values within acceptable limits between 239Hb and 309Hb
- Visual inspection showed heavy scoring on the compressor side bearing journal and minor scoring on the exhaust side bearing journal

Machining in process to restore journal surface

As the damage on the compressor bearing journal was more significant, Goltens' In-Situ machinists needed perform fine grinding and honing on the journal to remove the heavy scoring.

As the damage to the exhaust side was less severe, Goltens was able to remove the lighter scoring without grinding the journal. Goltens technicians were able to polish the journal to restore the journal with only honing and machine polishing.
