CRANKPIN REPAIR

SWD-WARTSILA 280 – JOURNAL ANNEALING AND GRINDING

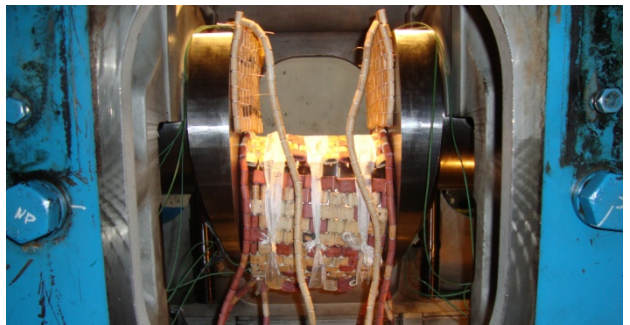
The Crankpin journal surface was severely scored with scratches measuring up to 0.40 mm deep (shown right). Additionally, the bearing failure had generated significant heat causing areas of severe hardness above 650 Brinell and run-out measurement of the adjacent main journal showed the shaft was bent with a run-out of 0.10mm.

Goltens initially ground 1.00mm from the crankpin to remove the heat cracks, scratches and hopefully the hardness. After this initial machining, the areas of high hardness remained. Further grinding 3.00mm total from the diameter revealed continued hardness up to 500 Brinell. Given that the maximum crankpin reduction of diameter is 5.00mm on this engine, Goltens advised the client that the only way to save the shaft was to stop the grinding process, anneal the crankpin to remove the hardness, and then complete the repair with a final grinding process.

- Rough machining to remove all cracks (3.0 mm dia.)
- Annealing crankpin to reduce harness from >650 Brinell to between 250-300 Brinell
- Post annealing straightening of the crankshaft (0.02mm after straightening)
- Crankpin journal ground to its final size 216.00mm (4.00mm undersize)
- Fillet radii ground to finished spec under journal surface
- Lube oil holes rounded off and polished
- Journal polished to 0.3Ra according the Maker's spec
