CRANKSHAFT REPLACEMENT ON DEUTZ RBV12M350 MAIN ENGINE IN MALTA SHIPYARD

LINEBORING AND CRANKSHAFT REPLACEMENT RESTORES BADLY DAMAGED ENGINE

PROJECT FACTS: CRANKSHAFT REPLACEMENT

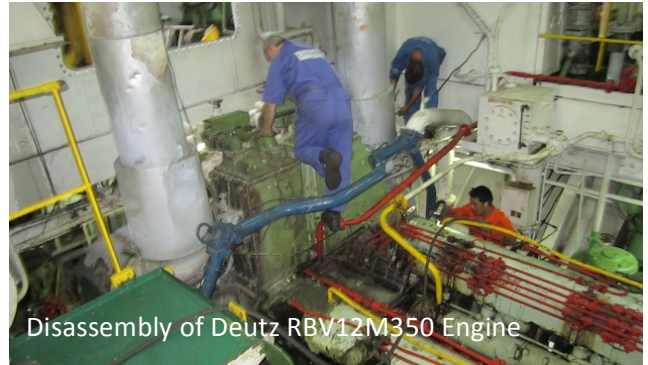
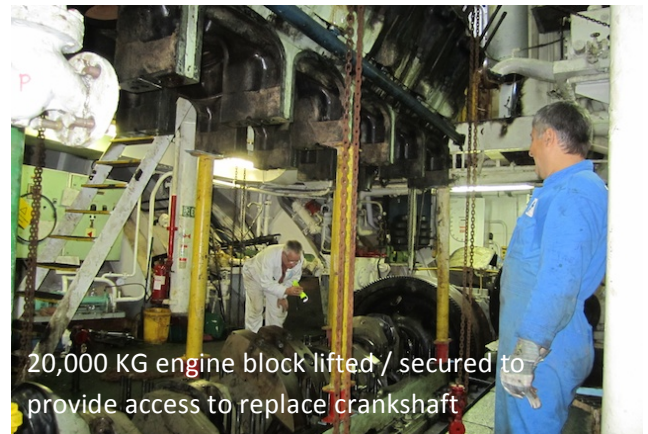
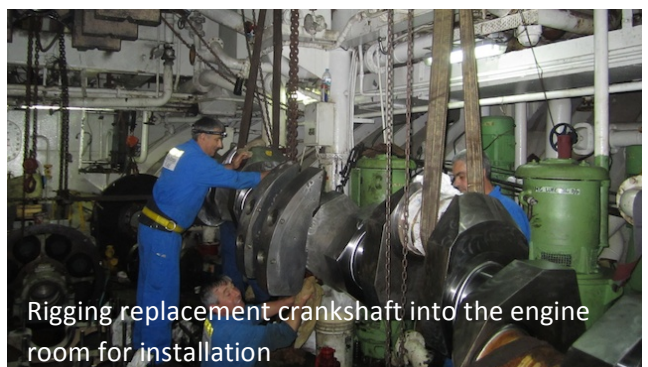
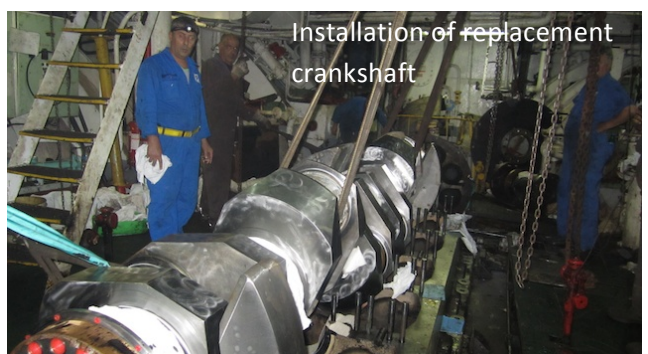
Goltens mobilized its Diesel and In-Situ machining teams to the shipyard in Malta and disassembled the engine, which included the removal of the 5,500KG flywheel and the lifting and securing of the 20,000KG engine block to gain access to remove the crankshaft.

Inspection revealed that main bearings No. 1, 2, 3 and 4 had spun in the bearing pocket and had caused severe damage in the bedplate and crankshaft. It was determined that the crankshaft was condemned and would require replacement and that the bedplate would need to be line bored to oversize. Goltens presented the recommendations to the superintendent and began efforts to line bore the bedplate, replace the crankshaft and restore the engine to service.

- Dismantling of engine and removal of crankshaft
- Measurement of bedplate
- Hardness and crack test on bearing pockets
- Machining of the bearing caps and blue fitting
- Line boring of bedplate to oversize +2mm and +3mm
- Rigging of replacement crankshaft and reassembly of engine
- Laser alignment and chocking the engine using ITW Polymers' Chockfast Orange chocking product
- Operational testing of the engine and successful sea trial

Goltens completed the crankshaft replacement, line boring of the engine bedplate and rebuild of the engine resulting in satisfactory operational testing and sea trials returning the vessel to service. All work was accepted by the Lloyds Register surveyor, insurance company and vessel superintendent.
