DIESEL SERVICE, CRANKSHAFT MACHINING, LASER ALIGNMENT AND ELECTROPLATING

CRANKSHAFT AND ENGINE BLOCK REPAIR WAUKESHA 12V-AT27GL SERIES

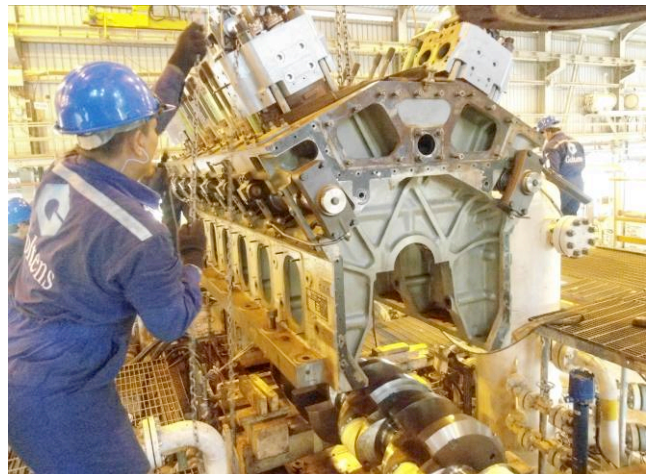
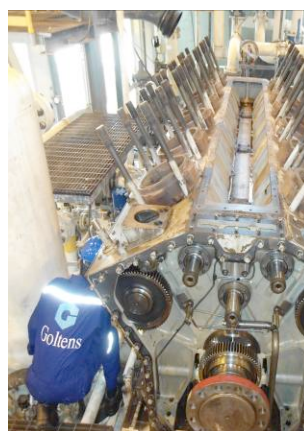
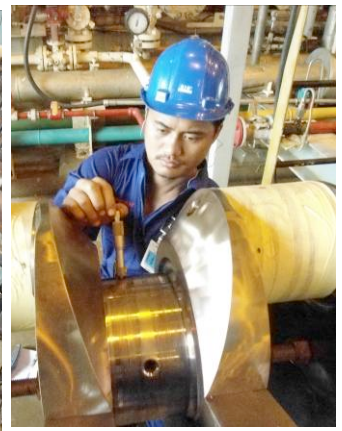
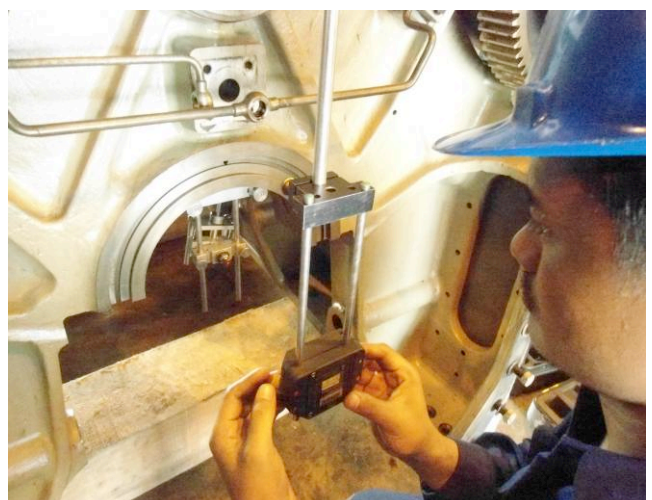
During the inspection of the engine, Goltens discovered that one of the engine's main journals and bearing caps had been damaged. Extensive fretting was discovered on #4 main bearing cap and extensive scoring was found on the bearing. Goltens recommended a laser alignment check on the bores, machining of the crankshaft and selective electroplating of the bearing cap.

- Disassembly of engine
- Relocate engine block to safe area for repairs
- Removal of crankshaft from engine block
- Laser alignment check on center line of main bearing bore
- Selective electro plating of #4 main bearing cap due to fretting on mating surface
- Machined main journal #4 by 1.0mm undersize at workshop
- Replaced crankshaft in engine block
- Engine reassembly and laser alignment
- Operational testing and commissioning
