IN-SITU MACHINING AND BEARING REBABBITING RESTORES POWERPLANT MAN B&W 9K80MC-S GENERATOR 896.00MM CRANKPIN AND BEARINGS

After suffering a bearing failure on Crankpin #4, a Jamaican powerplant operator called in Goltens to perform an inspection of the crankshaft and propose a course of repair.

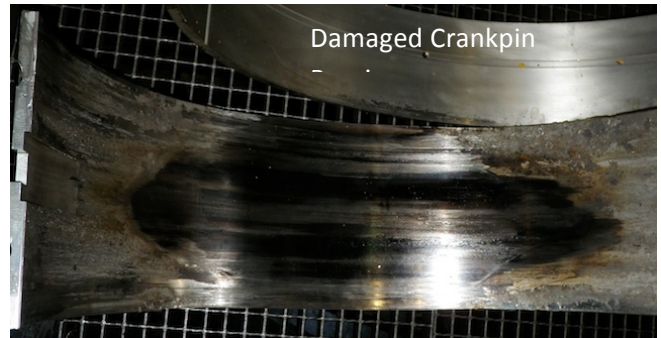
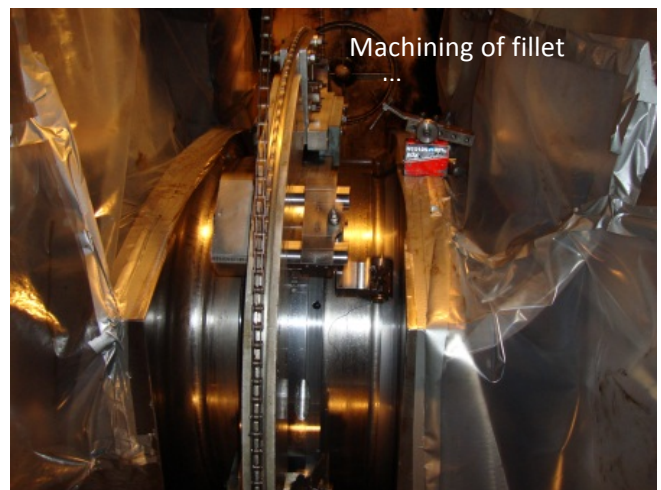
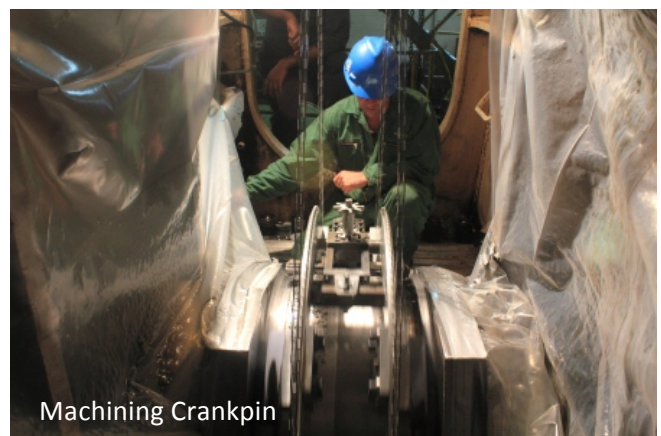
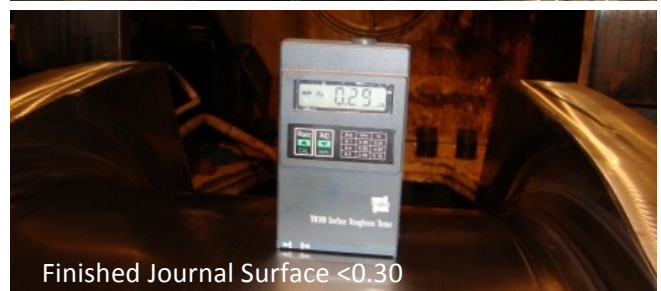
- Full NDT inspection (Magnaflux and Hardness)
- Machining of new fillet radii
- Machining of crankpin #4 to -05.00mm undersize (891.00mm)
- Superpolishing crankpin to roughness less than 0.30 Ra
- Manufacture of blueing dummy and performance of contact tests to verify contact surfaces within manufacturer's specs.
- Rebabbiting and finish machined reconditioned big end bearings to undersize -05.00mm
