GOLTENS FORMS A NEW BOND IN CEMENT FACTORY WITH METAL STITCHING

SULZER 16ZV40-48 DIESEL GENERATOR

PROJECT FACTS: SPCC Generator

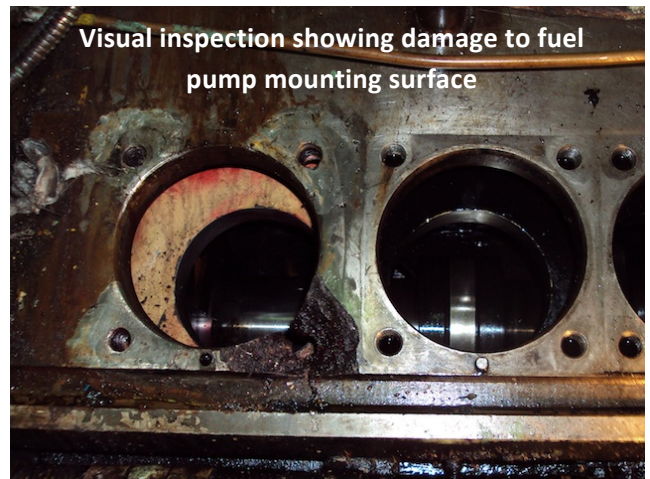
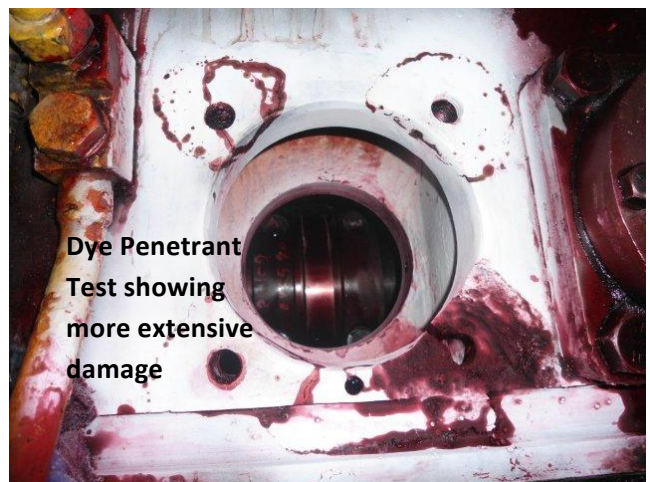
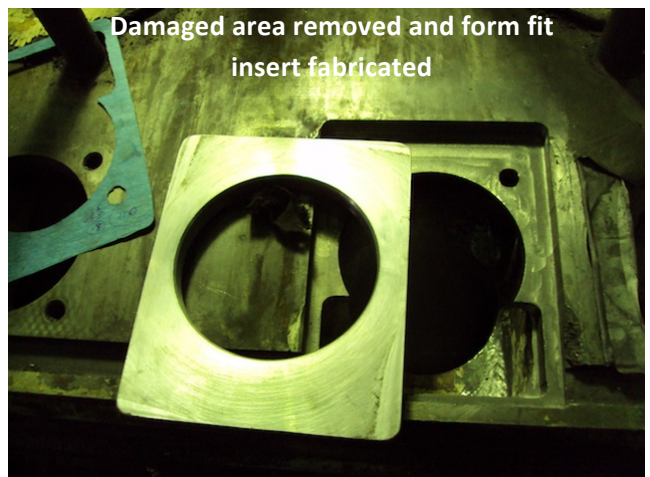
Post drilling, the new fuel pump mounting insert was tested by loading the bolts to 300kg. The load test was successful and rebuilding of engine was resumed.

Goltens proposed to mill out the damaged area and fabricate a form fit insert to be metal stitched into place to repair the block.

Goltens milled out the damaged area and completed post machining dye penetrant checks to ensure that 100% of the damage had been removed. Goltens fashioned a template of the damaged area and fabricated an insert that was machined to fit neatly in damaged area of the block.
