CRANKSHAFT JOURNAL MACHINING

PIELSTICK 18PC4.2V ENGINE

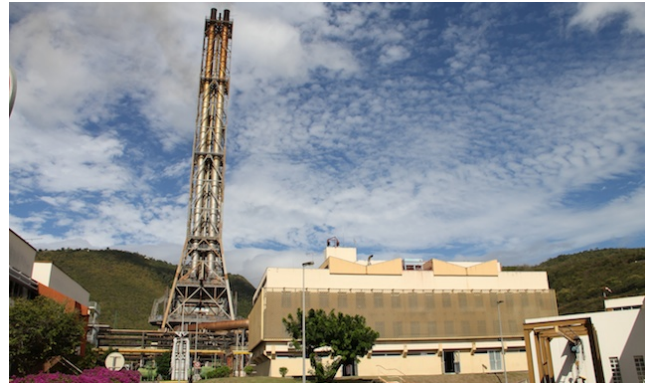
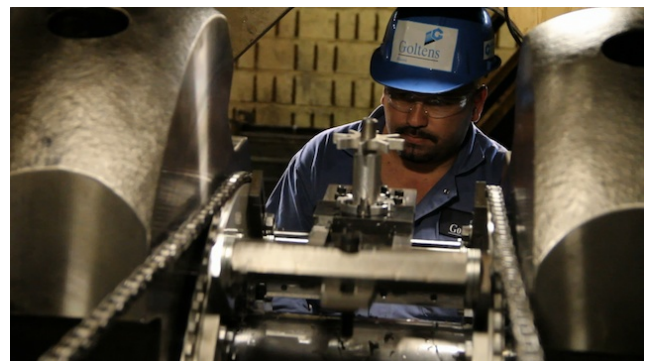
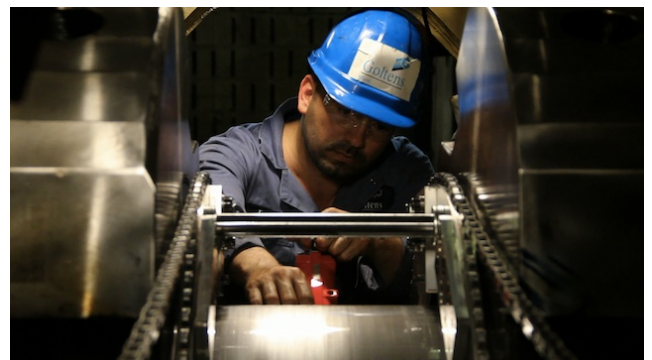
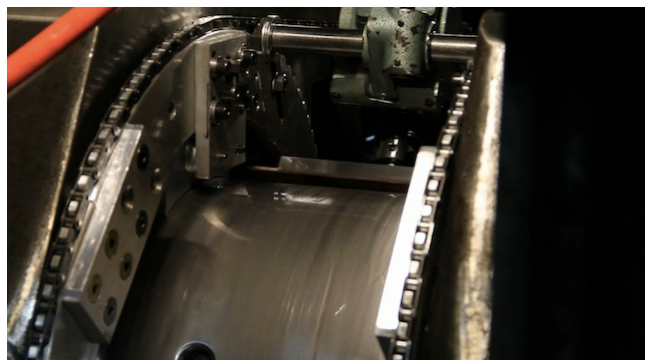
- Magnaflux and Hardness checks on crankshafts
- Run out and ovality checks
- Machining of 0.5 mm off Crankpin #6
- Machine polishing of Crankpin #6 and #8 to a finish of 0.2Ra
- Finish grinding of fillet radii on Crankpin #6

Engine Output:	21,517KW
Crankpin Length:	342.00mm
Original Crankpin Diameter:	465.00mm
Finished Crankpin Diameter:	464.50mm
