IN-SITU “IN A BOX”

6RT-FLEX-50B CRANKSHAFT RENEWAL

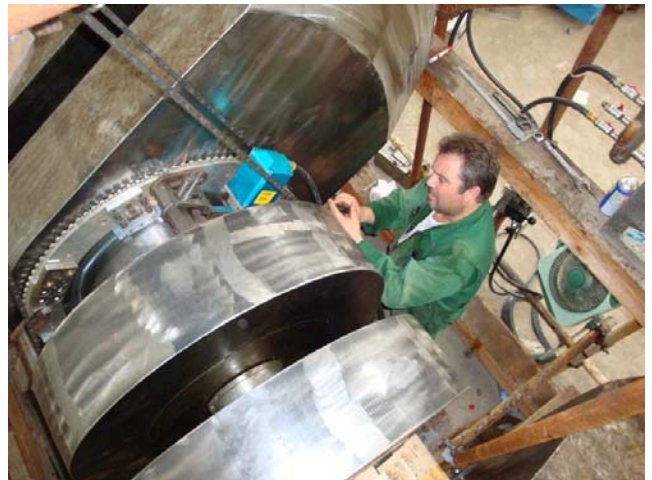
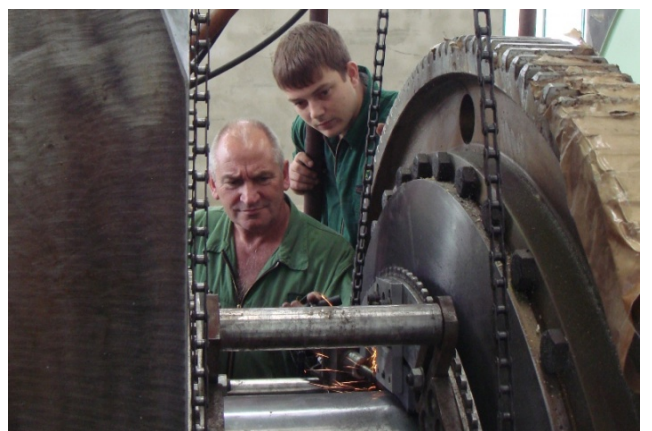
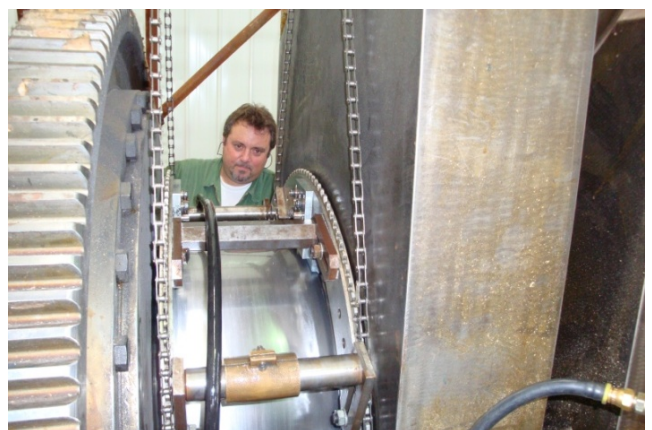
CRANKSHAFT FACTS: Wartsila 6RT-FLEX 50B

Weight:	55 tons
Crankshaft Length:	7560 mm
Throw:	2850 mm
Journal Diameter:	600 mm
Crakpin Diameter:	600 mm

- Assessment of fillet radii (which are normally out of line due to the shaft manufacturing process)
- Grinding of four new fillet radii for reference
- Grinding one main journal to undersize 0.50 mm
- Grinding one main journal to undersize 0.50 mm
- Manufacture of bluing and lapping dummy at specific size
- Super polishing by machine
