WARTSILA 9R32E ENGINE BLOCK REPLACEMENT GENERAL CARGO SHIP IN NYC

TRANSATLANTIC

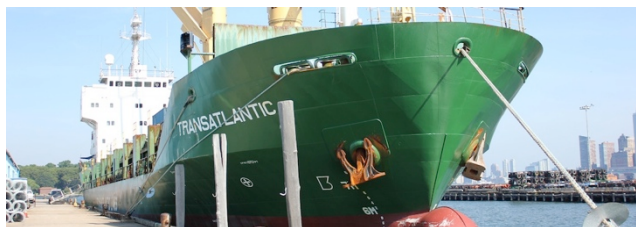
Removal of the damaged block

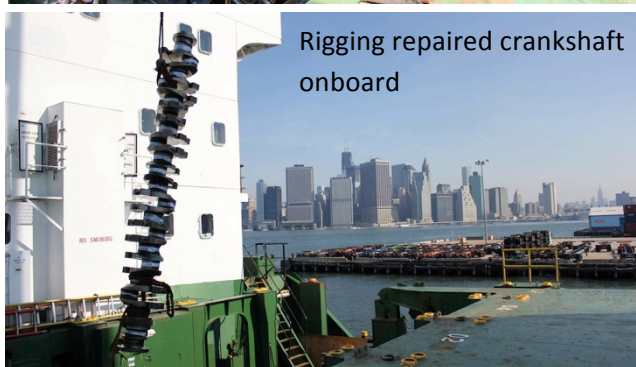
Rigging repaired crankshaft onboard
