EMERGENCY STERN TUBE BEARING REBABBITTING

AFT STERN TUBE BEARING RENEWAL COMPLETED IN 5 DAYS

NORDIC FIGHTER

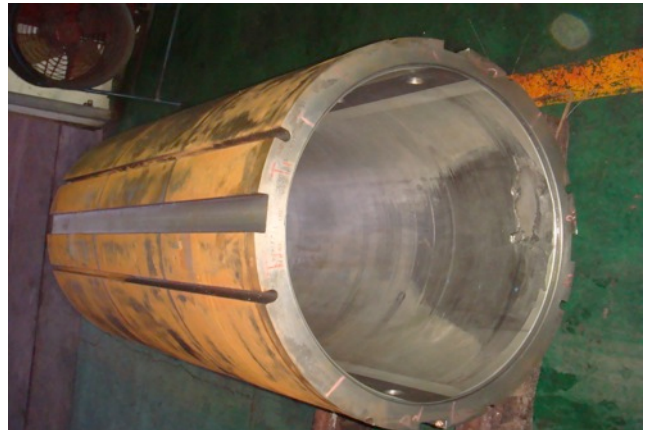
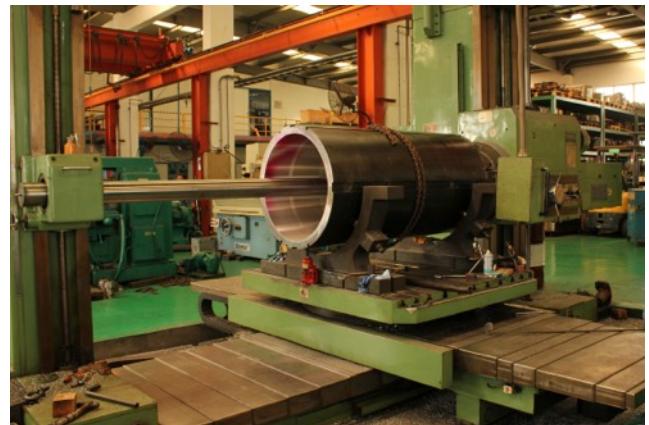
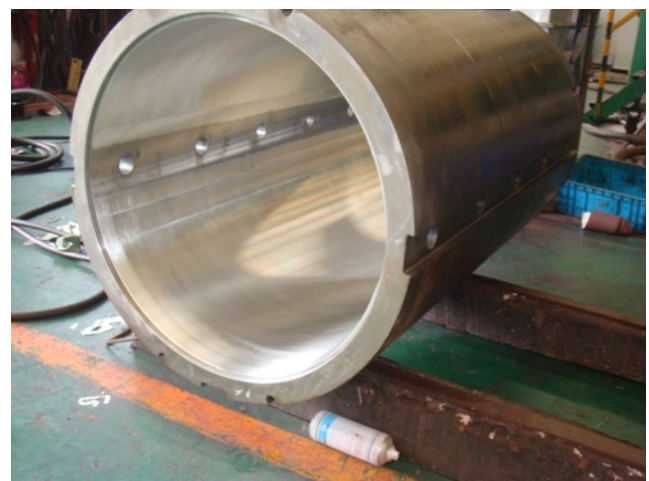
During the dry docking of the Oil Product Tanker, Nordic Fighter, the vessel's stern tube was inspected before the tail shaft was removed. The stern tube bearing was observed to have damage in the aft bottom area of the stern tube.

- Incoming inspection of AFT stern tube bearing before and after removal of damaged white metal bearing material;
- Rebabbitting the AFT stern tube bearing;
- Machining white metal inside diameter according to owner provided drawings;
- DNV class inspection at Goltens Shanghai workshop witnessed by the vessel owner;
- Complete UT inspection and dye checking at workshop;
- Laser alignment checking of the tail shaft alignment;

Goltens' workshop completed this rebabbitting service within 5 days. Goltens Shanghai coordinated the entire operation and arranged forwarder, local agent and DNV Class Surveyor in order to meet the owner's urgent vessel schedule with the shipyard.
