IN-SITU ANNEALING AND MACHINING RESTORES PIELSTICK 2.5 GENERATOR POWER STATION IN FRENCH GUYANA

PROJECT FACTS: French Guyana Powerplant

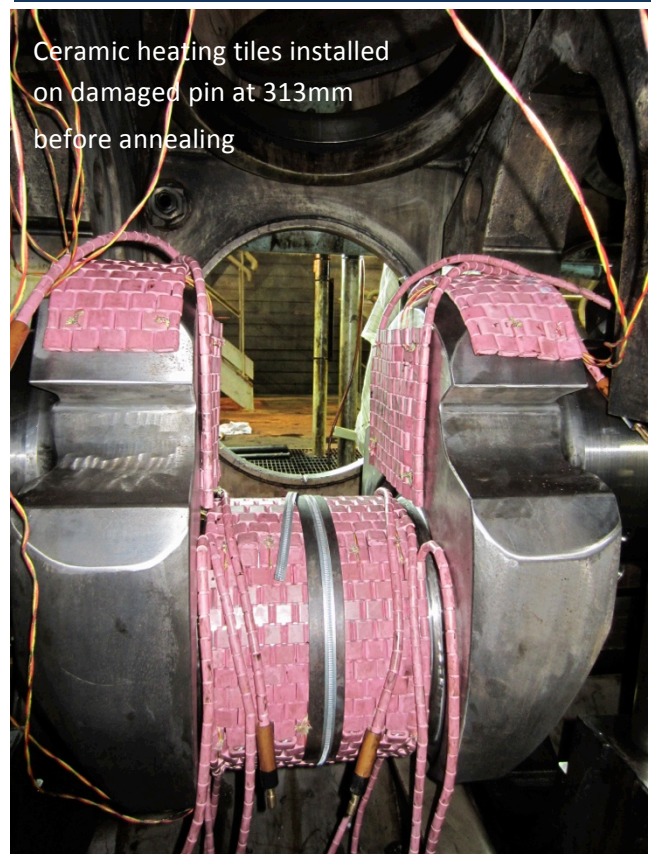
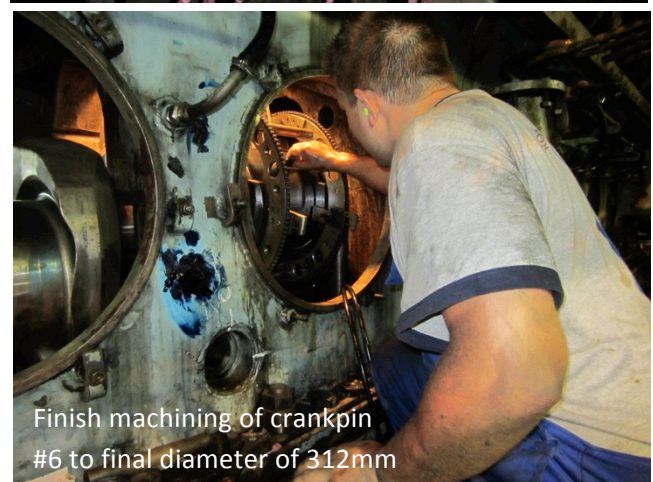
A power plant in French Guyana contacted Goltens after experiencing a casualty on its #9 generator, a Pielstick 2.5 18V. Inspection revealed that crankpin number 6 had suffered a significant casualty resulting in significant damage to the running surface as well as the fillet radii.

Further evaluation also revealed extremely high hardness areas at both the top and bottom of the crankpin with peak values as high as 647hB (Hardness Brinell). Goltens discussed removing material from the journal until it was free of cracks and then remeasuring the hardness. At -2.00mm the journal was free of cracks but the hardness remained with peak values of 600hB.

Based upon the extent of the hardness, Goltens estimated that it would extend, at a minimum, as deep as 6.00mm or more and advised the customer that it was possible to reduce the hardness via annealing and salvage the crankshaft at a undersize of only -3.00mm. The customer accepted the proposed repair method and Goltens mobilized its annealing equipment and heat treated the crankpin before finish machining and polishing the crankpin.

- Full NDT inspection (Magnaflux and Hardness)
- Machining of crankpin #6 to -2.00mm undersize pre-annealing
- Annealing of crankpin #6 to reduce hardness to below 325 hB
- Straightening of crankshaft
- Finish machining and superpolishing at -03.00mm undersize at 312.00mm
- Superpolishing crankpin # to less than 0.3Ra
- Polishing / blue fitting crankpins 1, 2, 3, 4, 5, 7, 8 and 9
