## RAPID RESPONSE FOR RUDDER STOCK ON-SITE MACHINING

### 2-DAY JOB COMPLETION TO KEEP YARD PERIOD ON TRACK FOR BULK CARRIER

#### PROJECT FACTS: RUDDER STOCK REPAIR

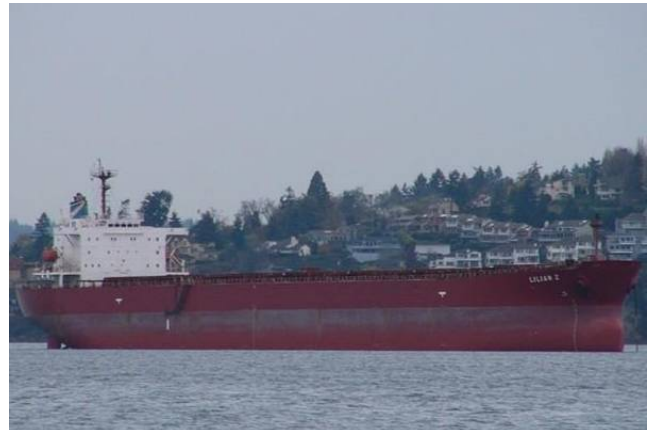
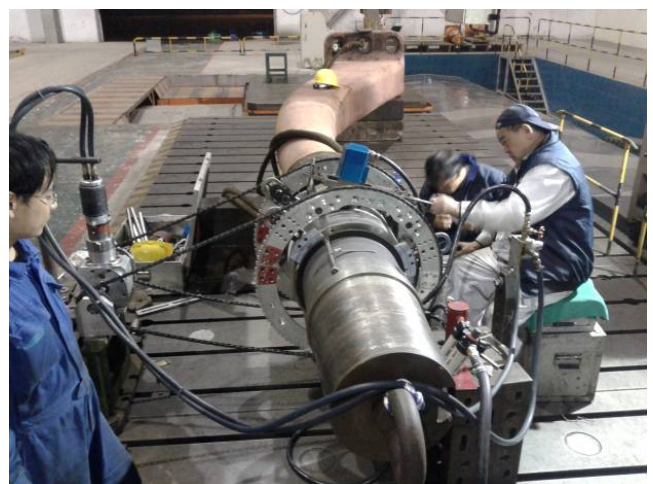
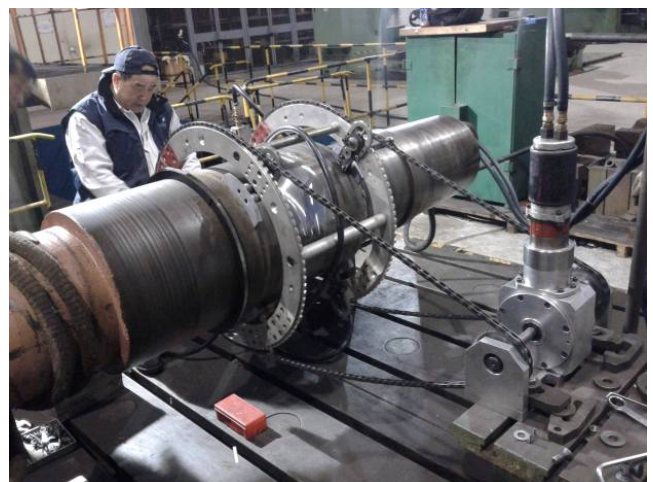
The 74,461 DWT bulk carrier Lilian Z was dry-docked at Chengxi Shipyard for completion of its 5-year survey. During the survey, wear and scraping was discovered on the rudder stock journal after the sleeve was removed. The attending superintendent was aware of Goltens' in-situ machining capabilities and immediately approached Goltens for a solution.

- Full cleaning of rudder stock journal;
- Complete inspection and measurement on rudder stock journal;
- Machining of 500mm rudder stock journal to 1.00mm undersize (Final OD: Ø499.00mm × Length 450.00mm)
- Fabricated dummy bearing for blue oil checking;
- Finish polishing of rudder stock journal;
- Final inspection and measurement of rudder stock journal;

Goltens workshop perfectly completed this in-situ machining within 2 days and coordinate coordinated with the shipyard and Class society in order to meet the vessel's tight schedule.
