## IN-SITU GUIDE RAIL MACHINING XY MILLING FOR A DREDGER IN DRYDOCK

### PROJECT STATISTICS: Guide Rail Machining

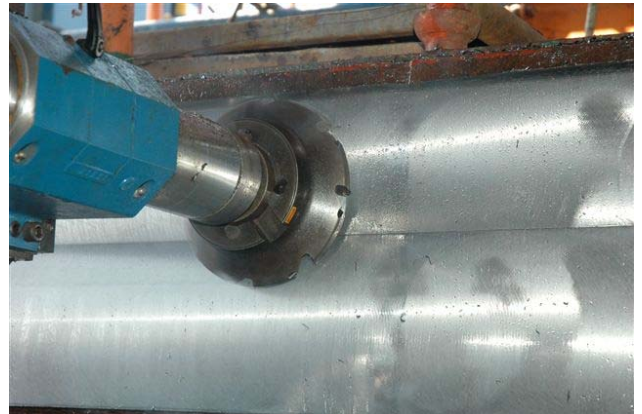
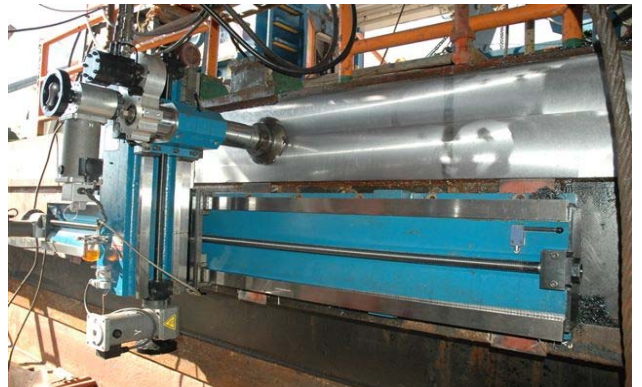
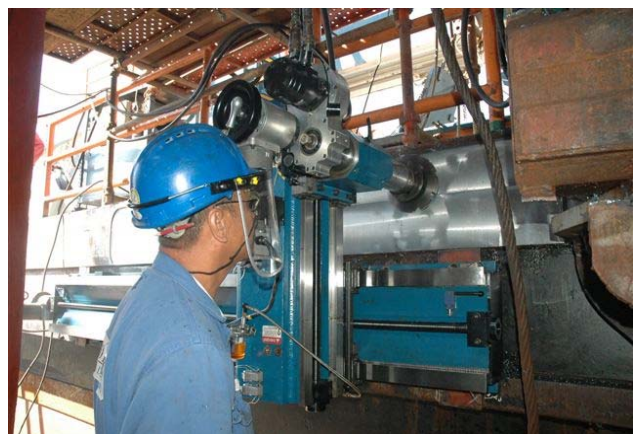
Inspection revealed that there had been distortion on the guide rails due to welding performed. The distortion affected both rails and covered a distance of over 7 meters of the 12 meter rails.

- Machining of rails on both sides with reference point given by the yard.
- Set up machine on each side 3 times to cover the length of 7 meters.
- Removed up to 6 mm in height to get the rail within the tolerances.

The job was completed to the full satisfaction of the owner over an 8 day period with 12-hour shifts due to yard restrictions. Capacity of milling machine employed is 3000 mm in X axis 600 mm in Y axis and 200 mm in Z axis.
